DEPARTMENT OF ENGINEERING GEOLOGY

INSTITUTE OF ROCK STRUCTURE AND MECHANICS
of the Czech Academy of Sciences

THEMATIC RESEARCH FOCUS

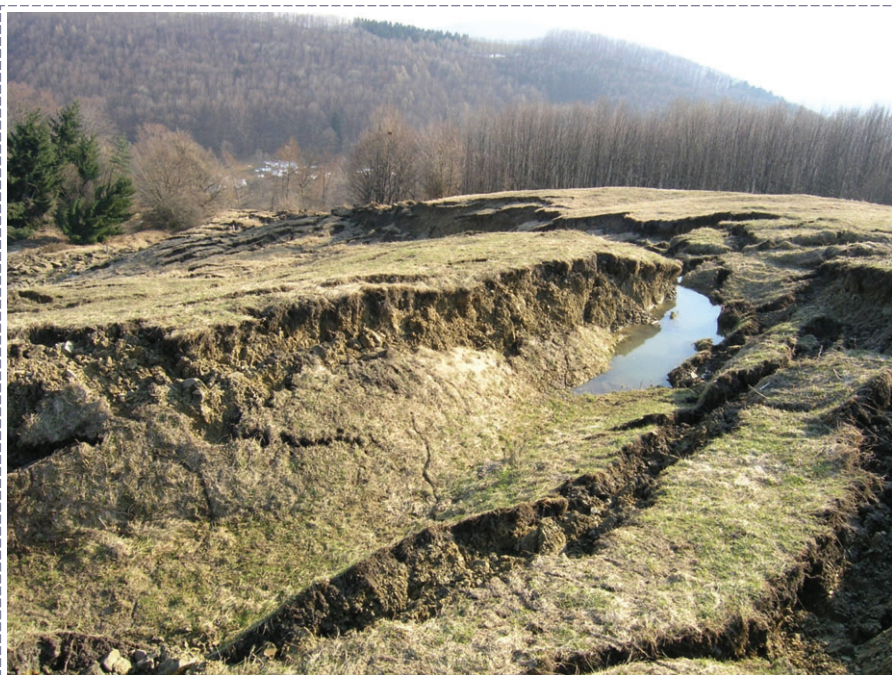
Landslide scarp in Hluboče, Biele Karpaty, Czechia. Landslide was triggered in spring 2006 after snow thawing. Photo J. Klimeš

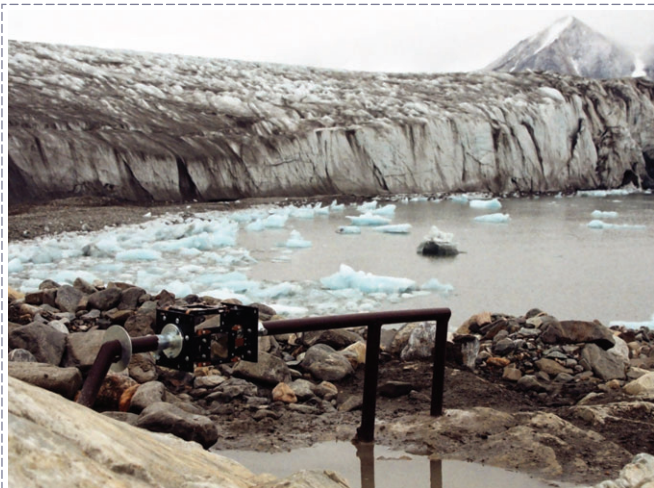
TM-71 crack gauge installed on fault in the forefront of the Hans Glacier in Hornsund, Svalbard. Photo F. Hartvich.

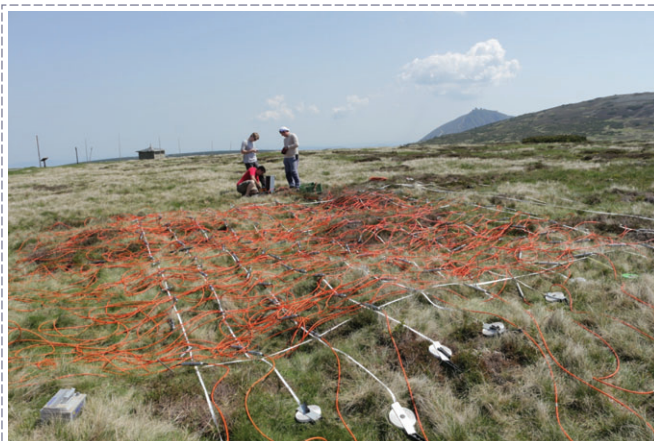
3D measuring of polygonal soils together with colleagues from the Charles University in Prague using an ERT system ARES at Modre Sedlo. In the background Mt. Sněžka (1602 m a.s.l.)

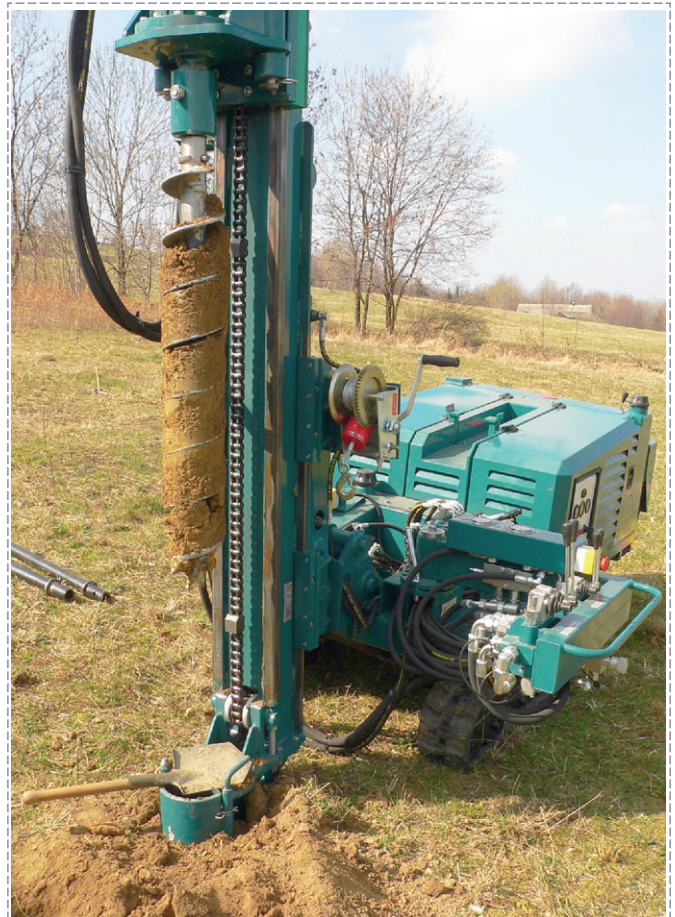
HVS 125 drilling and taking samples from a fault zone in Bílá Voda, Czechia. Photo F. Hartvich.

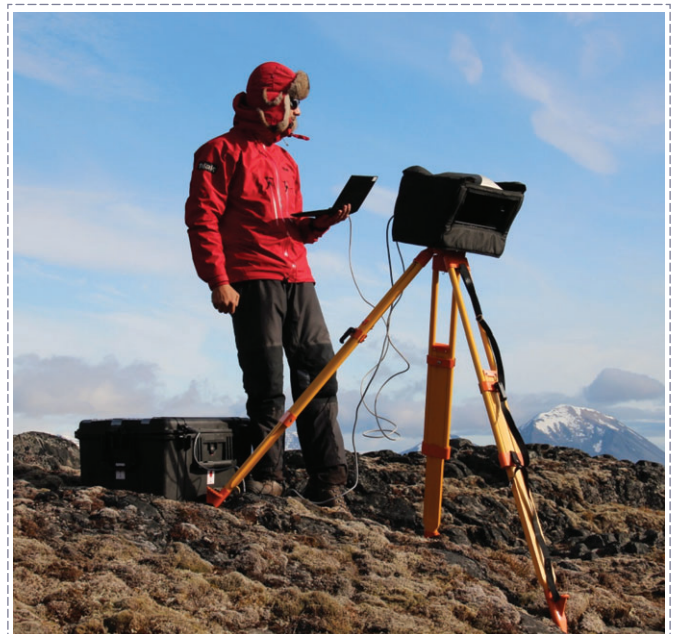
Jan Blahůt is surveying fault area in Hornsund, Svalbard with ILRIS3D terrestrial laser scanner. Photo M. Hladká.

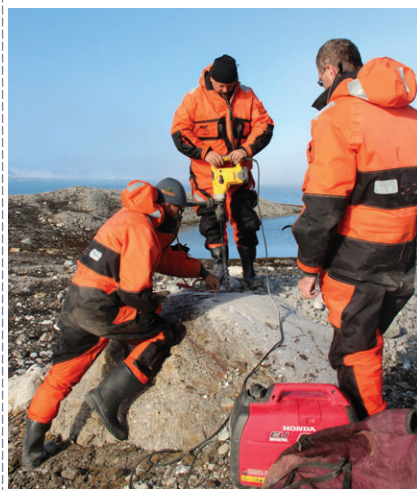
Josef Stemberk, Filip Hartvich and Jan Blahůt installing GNSS measuring place in Hornsund fjord, Svalbard. GNSS measurement campaigns are used to monitor regional tectonic movements and isostatic uplift of the Hornsund fjord area. Photo M. Hladká.
